European Journal of Advances in Engineering and Technology, 2020, 7(2):34-40

A Case Study of Abnormal Heat Generation of Automobile Engine Connectors during a Combined Environmental Test

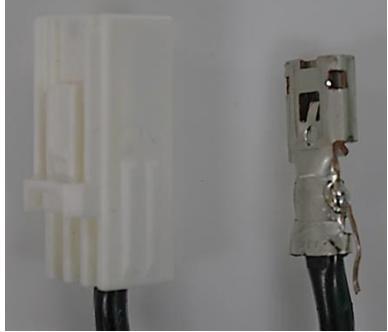
The combined environmental test of the electrical distribution box, shown in Fig. 1, was carried out with it mounted onto a vibrating table installed in a temperature-controllable camber. The box was excited at 4.5 G acceleration with a frequency range of 20~50 Hz. During this test, the connector was electrically charged with an applied voltage of 14.5V for 360 cycles (=360 hours). One cycle was composed of a 45-minute power-on and a 15-minute power-off. The fifteen environmental thermal cycles were applied, as shown in Fig. 2. The material of the connector was CuSn₄, and the surface of the connector was coated with tin about 10 μ m. The temperature of the connector was monitored by soldering the thermocouple as shown in Fig. 3.The test of the distribution box was carried out twice. In the first test, no failure occurred in the blower connector. However, there was abnormal heat generation in the same blower connector during the second test.Normally, the peak temperature of the connector rose in the 100 – 120 °C range during the test period, but for the connector in this study, the temperature rose abnormally to 193.8 °C after 191 hours.

Fig. 3 Thermocouple attached to female connector for monitoring temperatures

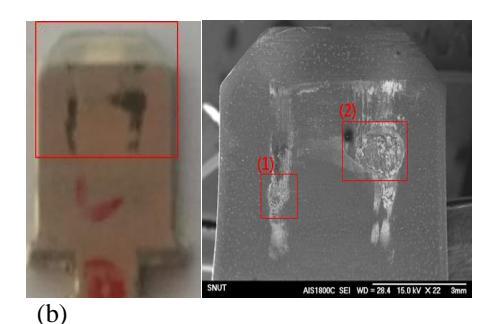
Fig. 5 is a photograph showing the surface condition of the front side of the male connector of the blower with abnormal heat generation during the complex environmental test. From Fig. 5(a), it is visually confirmed that fretting wear occurred. In addition, Fig. 5(b) shows clearly that fretting corrosion with white oxide particles occurred in two zones. Fig. 6 is SEM micrograph of locations (1) and (2) of thefront surface of the failed blower male connector in Fig.5.The widths of fretted zones (1) and (2) were measured and found to be 626 μ m and 1467 μ m, respectively. It was noted that a considerable amount of oxide debris was scattered around the contactarea where fretting corrosion had occurred.Fig.7 shows the rear surface of the male connector of the failed blower with fretting wear after the complex environmental test. The fretting distances were 1630 μ m and 1555 μ m, and for an average value of 1593 μ m. Fig. 8 is an enlarged SEM photograph taken to measure the width of the fretting wear area with respect to positions (1-1), (1-2), (2-1), and (2-2) inFig.7. The widths of (1-1), (1-2), (2-1) and (2-2) were measured and determined to be 216 μ m, 211 μ m, 235 μ m and 233 μ m, respectively.The widths arenearly constant. From Fig.5 to Fig.8, it can be confirmed that fretting corrosion occurred in the longitudinal direction of the blower connector where abnormal heat generation occurred during the combined environmental test.

Fig. 5(a) Front surface of the failed male connector of the blower and (b) a magnified image of its surface with fretting wear after the complex environmental test

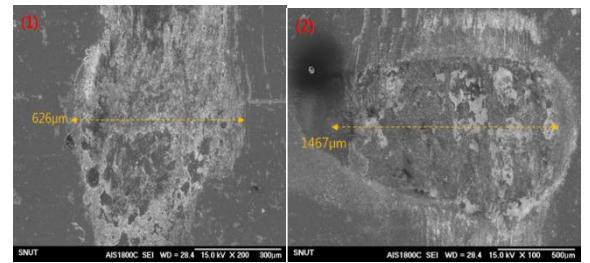
Fig. 6 SEM micrograph of (a) location (1) and (b) location (2) on the front surface of the failed blower male connector shown in Fig. 5

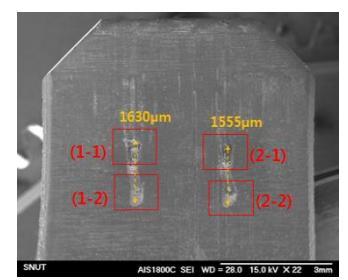
Fig. 7 Rear surface of the failed blower male connector with fretting wear after the combined environmental test

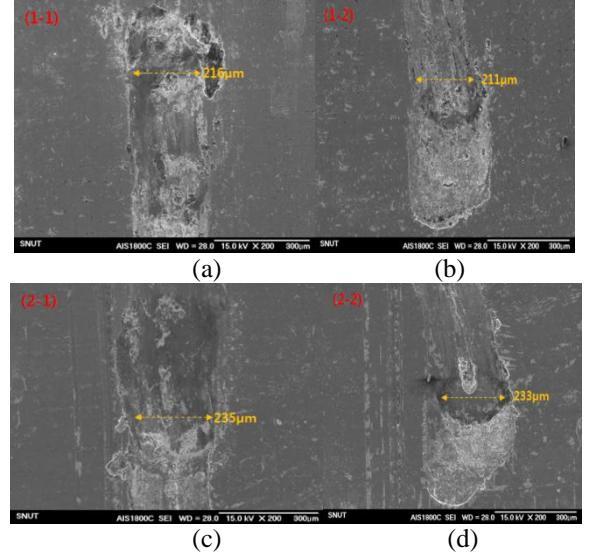
Fig. 8 SEM micrographs of the fretting wear surfaces of (a) location (1-1), (b) location (1-2), (c) location (2-1) and (d) location (2-2) on the rear surface of the blower male connector shown in Fig. 7

The average diameter of the contact zone is 223.8 μ m on the rear side of the connector, as shown in Fig.8, where the abnormal heat occurred. In addition, it was confirmed that the average contact diameter of the connector without abnormal heat generation is 272.5 μ m, which was approximately 49 μ m smaller than the connector with abnormal heat generation. Assuming that fretting wear is mainly generated in the longitudinal direction of the connector, the contact diameter of the connector can be assumed to be proportional to the width of the fretting wear region. The contact diameter is proportional to one-third of the power of the contact force according to the Hertz equation [6]. Therefore, it can be assumed that the connector with abnormal heat generation has less contact force than the connector without abnormal heat generation. In addition, it was confirmed that the fretting zone length in the longitudinal direction of the connector without abnormal heat generation. In addition, it is approximately 1125 μ m longer than that (= about 475 μ m) of the connector with no abnormal heat generation. It is also assumed that the fretting distance is longer than that of the abnormal heating connector, as less contact force leads to a longer sliding distance under the same vibration conditions. In general, the fretting distance is, the greater the accumulation of oxides becomes on the contact part, which shortens the fretting lifetime.

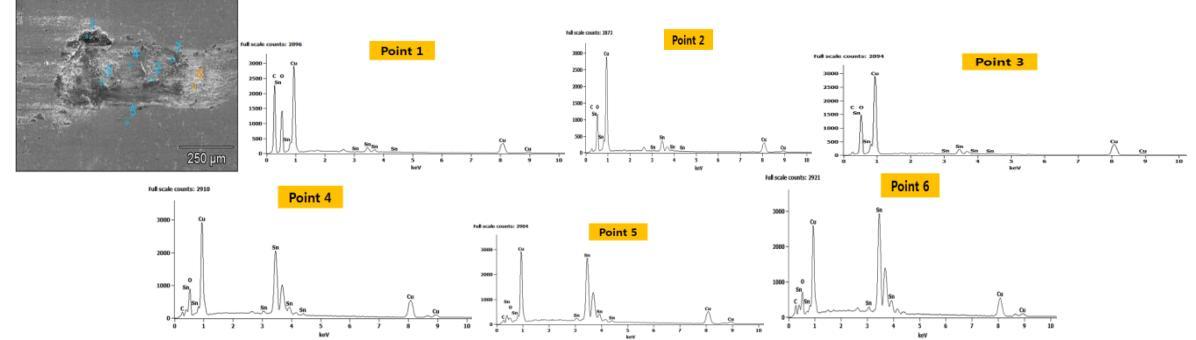
A chemical composition analysis was conducted by means of EDS of the connector contact area and on the non-contact area of the connector where abnormal heat generation occurred. Fig. 9 shows the EDS results of several points on surface area (1-1) of the rear surface of the blower male connector shown in Fig. 8. Table 1 summarizes these test results. Table 1 shows that at point (3), which is located at the center of the fretting corrosion zone, the concentration of oxygen at point (5), where no contact occurred, is about 14.5%, which is very low compared to those of the other points where fretting corrosion occurred. Additionally, the concentration of tin at the same point is close to 31%, indicating that the tin plating remains. The small amount of tin at point (3) indicates that the tin plating is mostly worn down and that the underlying copper is exposed. Except for the point at whichno contact occurred, the concentrations of oxygen at positions (1), (2), (3), (4), and (6) are in the range of 30~50%, suggesting that these points are covered with oxide film or oxide debris. It can be assumed that the electrical contact resistance is increased due to these nonconductive oxides. Therefore, the oxides which accumulate due to fretting corrosion may increase the resistance at the connector contact area, and the increased resistance may influence the abnormal heat generation of the connector.

Fig. 9 SEM micrographs of location (1-1) of the rear surface of the male connector of the blower shown in Fig. 8 and EDS results of several points on the surface

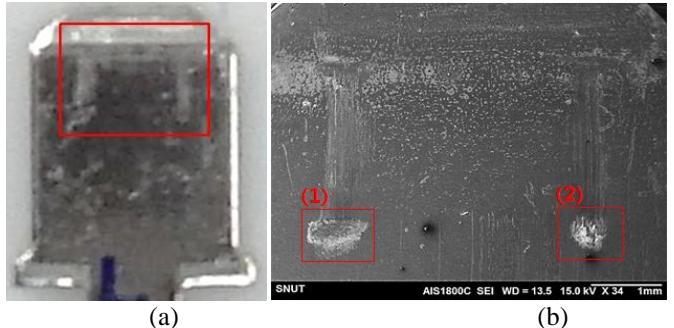
Fig. 10 shows the front surface of a male connector of a blower which passed the combined environmental test without abnormal heating and a magnified image of its surfaces showing fretting wear. It can also be seen that there are two zones of fretting wear at the contact points. Fig. 11 is SEM micrograph of locations (1) and (2) on the front surface of the male connector of the passed blowershown in Fig. 10. However, it can be seen that the size of the fretted zone is smaller than that of the connector where abnormal heat was generated. Fig. 12 shows the rear surface of a male connector of a passed bower, which is the same connector shown in Fig. 11. A magnified image of a surface with fretting wear after combined environmental test is also shown. The two vertical scratches in Fig. 12 are judged to have occurred during the removal of the connector, and two small fretted zones can be observed in this figure. Fig. 13 shows SEM micrographs of location (1) and location (2) on the rear surface of the male connector of the passed blower in Fig. 10. The width and the length of the fretted zone (1) are 283 μ m and 518 μ m, respectively, and the corresponding width and length of zone (2) are measured and found to be 262 μ m and 445 μ m. That is, the average width and length of the fretted zones are 272.5 μ m and 481.5 μ m, respectively.

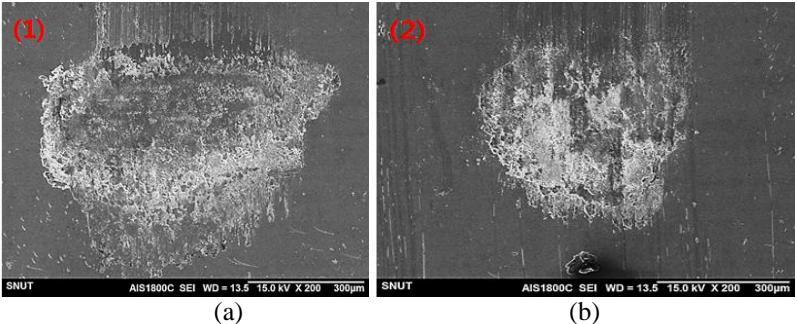
Fig. 11 SEM micrographs of (a) location (1) and (b) location (2) on the front surface of the passed male connector of blower in Fig. 10

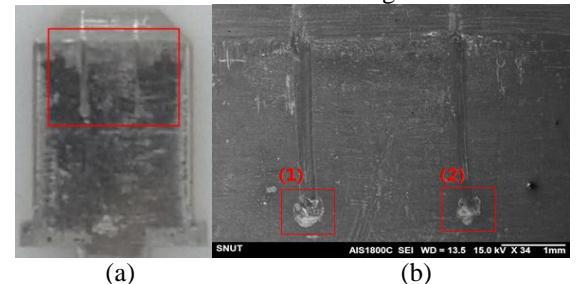
Fig. 12(a) Rear surface of the male connector of a passed blower and (b) magnified image of its surfaces showing fretting wear after the combined environmental test

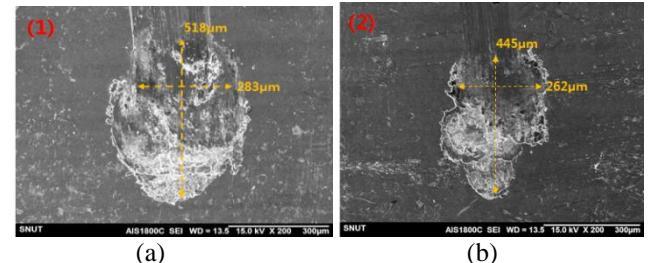
Fig. 13 SEM micrographs of (a) location (1) and (b) location (2) on the rear surface of the passed male connector of blower shown in Fig. 12

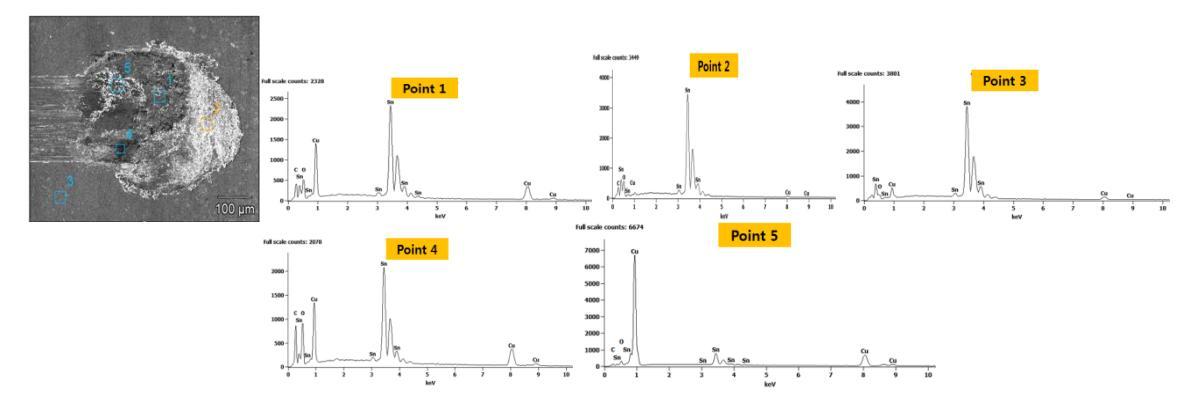
A chemical composition analysis was also conducted using EDS on the fretted zone and the non-contact zone of the connector where abnormal heat generation did not occur. Fig. 14 shows SEM micrographs of location (1) of the rear surface of the male connector of the passed blowershown in Fig. 12. Also shown are EDS results of several points of the surface. Table 2 summarizes these EDS test results. Table 2 shows that the oxygen concentration at location (3), which is the surface withoutcontact, is about 19%, which is much lower than those of other locations where fretting corrosion occurs. The tin concentration at location (3) is 65%, suggesting that the tin plating remains intact. At position (2), where white oxide debris has accumulated, the oxygen concentration is 48%, the copper concentration is 2%, and the tin concentration (5), at the center of the zone where fretting corrosion occurred, the oxygen concentration is very low at about 9%, the tin concentration is approximately 9%, and the copper concentration is about 74%, indicating that the tin plating is mostly worn away, leading to metal-to-metal contact. Therefore, it is considered that less heat was not generated due to metal-to-metal contact compared to the connector which did undergo abnormal heat generation.

Fig. 14 SEM micrographs of location (1) on the rear surface of the male connector of the passed blower shown in Fig. 12 and EDS results of several points on the surface
