Fatigue Bending Endurance Evaluation of an Automotive Air Conditioner Hose

Fatigue failures of air conditioner hoses occur due to the stresses caused by complex loads during use. We intend to investigate experimentally the relationship between the bending curvature radius of an air conditioning liquid hose and the bending fatigue lifetime as directly affected by the design of the hose. A device for measuring the bending curvature radius was developed and applied to develop a bending fatigue endurance testing device for these types of hoses, and the fatigue damage mechanisms of the hoses were studied. The fatigue lifetimes were almost inversely proportional to the axial strain due to rotational loading, except for a case with cross-sections excessively reduced by 33.3%. Given a large diameter reduction ratio, the inner rubber becomes excessively deformed in the cross-section of the area where local buckling occurs, with the inner rubber and reinforcing layer becoming completely destroyed along with leakage with external rubber.

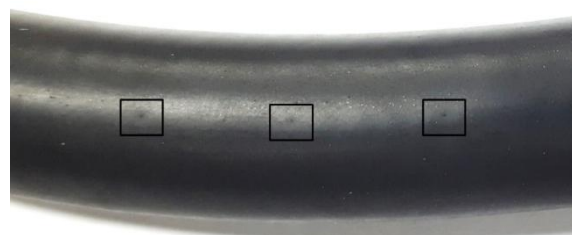
Fig. 3 Pinpricks on the outer layer of the air conditioning liquid hose

specimen. In this study, fatigue tests were performed with a radius of curvature between 3.2 mm and 29.8 mm, corresponding to a maximum diameter reduction ratio of 33.3% to 4.3%. If the refrigerant leaks due to damage of the inner rubber layer of the hose, the leakage occurs through the pinprick hole of the outer rubber layer. Accordingly, the definition of a hose failure was not assumed to occur when the outer layer rubber burst, but rather when liquid leakage occurred in the outer rubber and the hose thus failed to function properly. In other words, the moment of that of the refrigerant leaked onto the outer layer surface at regular intervals during the fatigue test was considered to be the moment of failure.

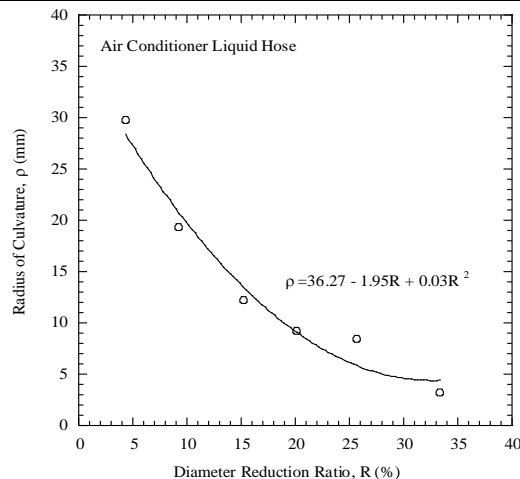
Fig. 7 Relationship between the radius of curvature and diameter reduction ratio of the liquid hose

Table 1 summarizes the maximum diameter reduction ratio, radius of curvature, fatigue lifetime, and fatigue fracture modes of the tested air conditioning liquid hose specimens. Fig. 7 shows the relationship between the maximum diameter reduction ratio (R) and the radius of curvature (ρ) of the hose. This relationship is expressed as follows:

$\rho = 36.27 - 1.95R + 0.03R^2$. As the radius of curvature decreases, the maximum diameter reduction ratio increases. In the range of approximately 5% to 15% of the maximum diameter reduction ratio, the radius of curvature decreased significantly by 60% from approximately 30mm to 12mm as the diameter reduction ratio was increased. On the other hand, in the range between 15% and 33.3% of the maximum diameter reduction ratio, the change in the radius of curvature was relatively small as the diameter reduction ratio was increased.

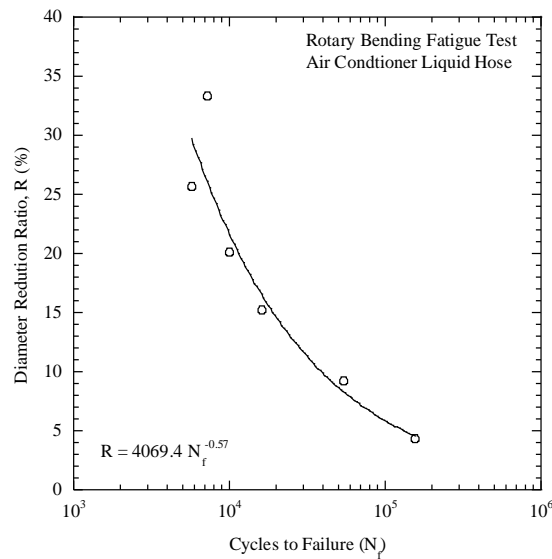
Fig. 8 Fatigue lifetimes as a function of the diameter reduction ratio of the liquid hose

Fig. 8 shows the relationship between the maximum diameter reduction ratio (R) and the fatigue lifetime (N_f) of the liquid hose. It was found to be almost inversely proportional to the hose diameter reduction ratio and bending fatigue lifetime. The fatigue lifetime was 156,065 cycles when the diameter reduction ratio was 4.3%, and the fatigue lifetime was 7,273 cycles when the diameter reduction ratio was 33.3%. Fig. 9 shows the fatigue lifetime as a function of the maximum axial strain of the hose. For air conditioning hoses, the outer diameter is 15.7 mm. If the hose has a minimum radius of curvature of 19.3 mm, the maximum axial strain ε_x of the curvature corresponds to

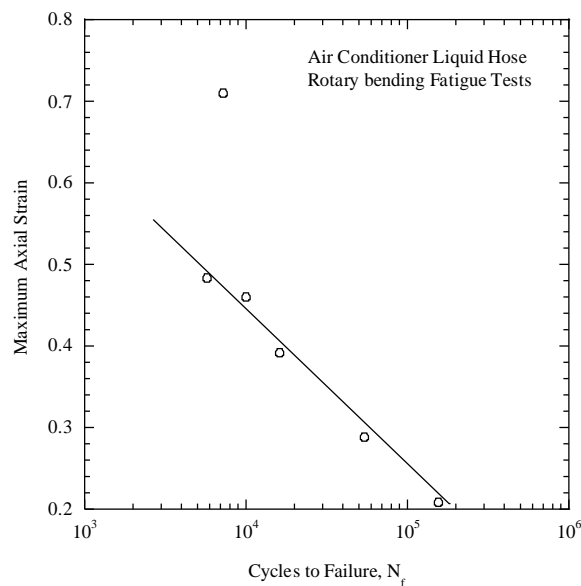
Fig. 9 Fatigue lifetimes as a function of the maximum axial strain of the liquid hose

. Fig. 9 confirms that the axial strain and fatigue lifetime were almost inversely proportional except for a datum that caused local buckling of rubber hoses during bending loads and showed excessively reduced cross-sections by 33.3%.

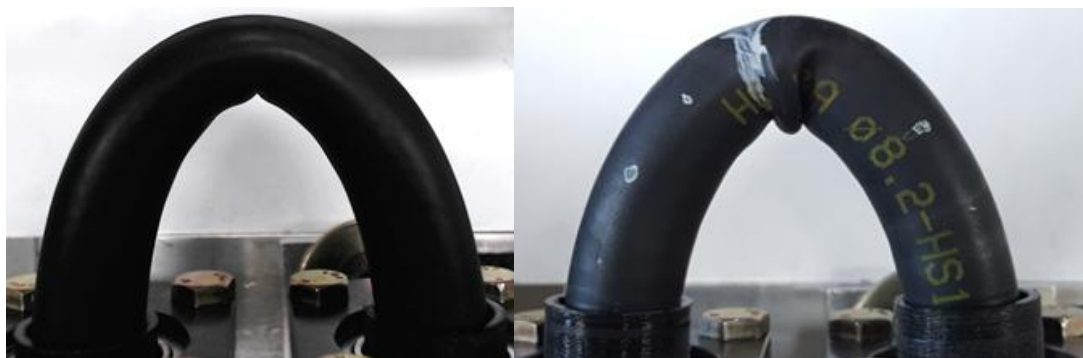
Fig. 11 Hose feature (a) before and (b) after the fatigue test with a diameter reduction ratio of 25%

Fig. 11 shows the shape before and after the fatigue test of the specimen with a diameter reduction ratio of 25%. Fig. 11(a) confirms that the hose center was folded into a certain shape prior to the start of the test, but no excessive local buckling occurred. On the other hand, Fig. 11(b) confirms that excessive local buckling occurred in the curved areas, similar to the specimen tested at an area reduction ratio of 33% with the shape after the fatigue test, as shown in Fig. 10(a). It was also confirmed that water leaked from pinpricks machined into outer layer rubber due to damage to the inner layer rubber and that water leaked from the folded part due to local buckling. Consequently, the occurrence of the local buckling of rubber hoses is thought to be due to repeated rotations of the inner layer rubber, resulting in excessive deformation of the inner layer rubber. The damage to the inner layer finally resulted in rupturing and leakage of the rubber hose. On the other hand, for the specimen tested with a diameter reduction ratio of 20%, relatively few cracks were observed in the inner layer rubber of the hose, which was subjected to tension and compression by repeated rotations, resulting in water leakage from pinpricks into the outer layer rubber. Fig. 12 shows the status of the failed fatigue specimen with a diameter reduction ratio of 20%. It was confirmed that water leaked from the pinpricks machined into the outer layer rubber of the area which underwent tensile and compressive stresses without damage to the reinforcement layer.
